BEHAVIOUR OF CONTINUOUS REINFORCED CONCRETE BEAMS DURING THE PATCH REPAIR PROCESS

Thesis submitted for the degree of
Doctor of Philosophy to the
School of the Built Environment,
Heriot Watt University,
Edinburgh.

March 2009

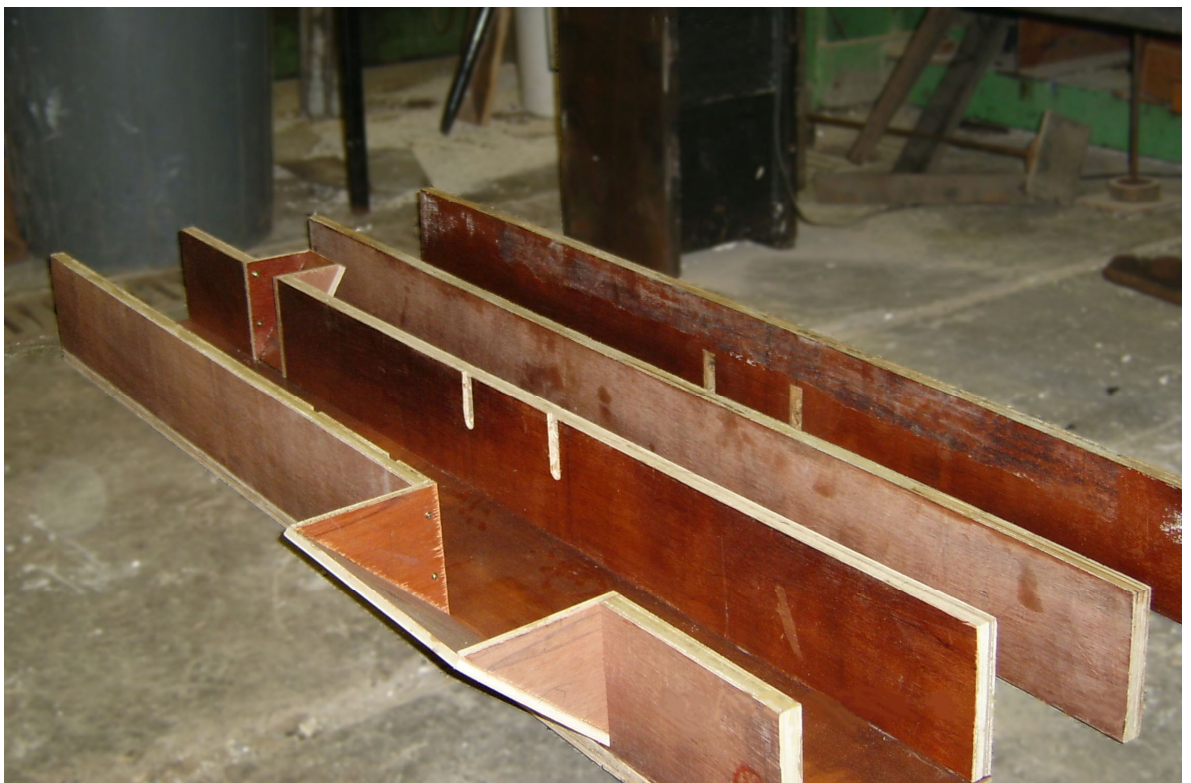
Fig. 5.4: Photograph of repair shutters for beam soffit (left) and top of beam (right)

Shutters were constructed to contain the flowing micro-concrete repair material (Fig. 5.4). Grooves were cut in the shutters to allow clamping to the beam sides without obstruction from the Demec buttons. A bead of silicon sealant was applied around the edges of the substrate concrete and the formwork was clamped in position.

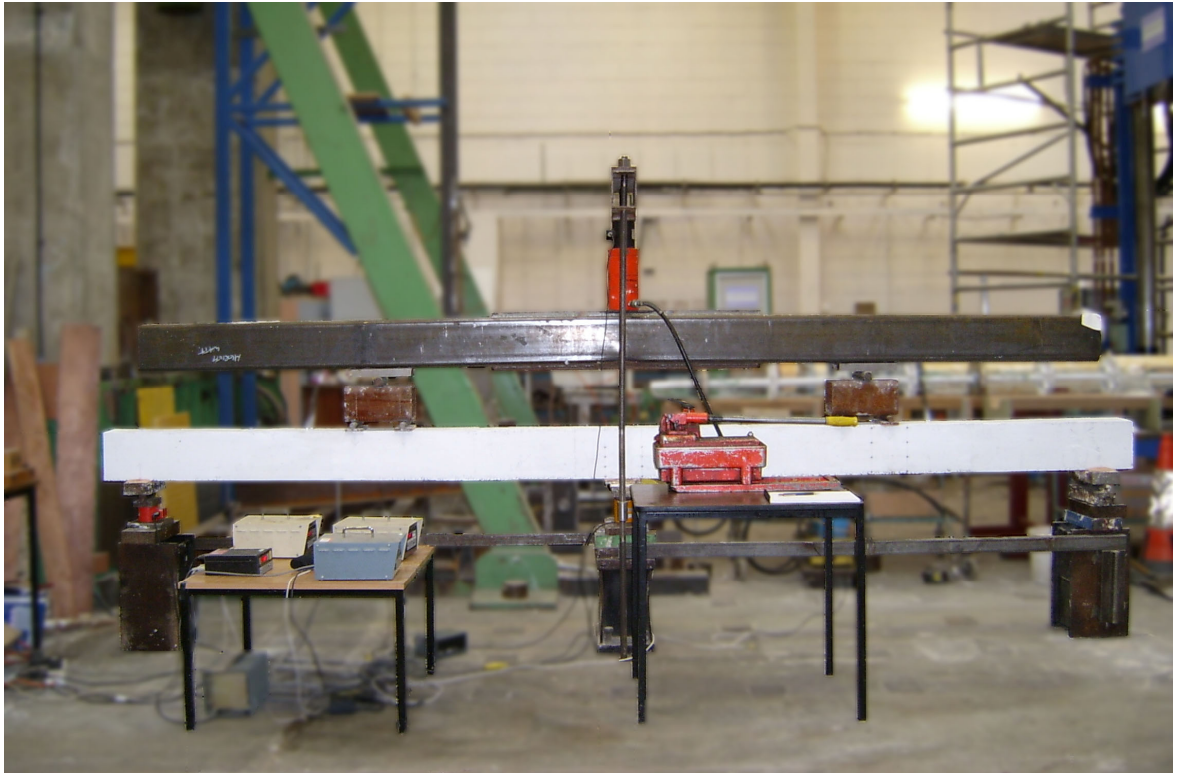
Fig. 5.5: Photograph of test set-up

Small 12mm thick plates were placed between the specimen and the “point load” rollers to avoid a local bearing failure under one of the point loads. The spreader beams and hydraulic jack were then positioned. A 50 tonne jack with a threaded piston and locking collar was used to enable locking of piston displacement. The “applied load” load cell was then placed on the fully retracted piston of the jack. Two 30mm diameter threaded steel rods were used to clamp the apparatus to the strong floor.

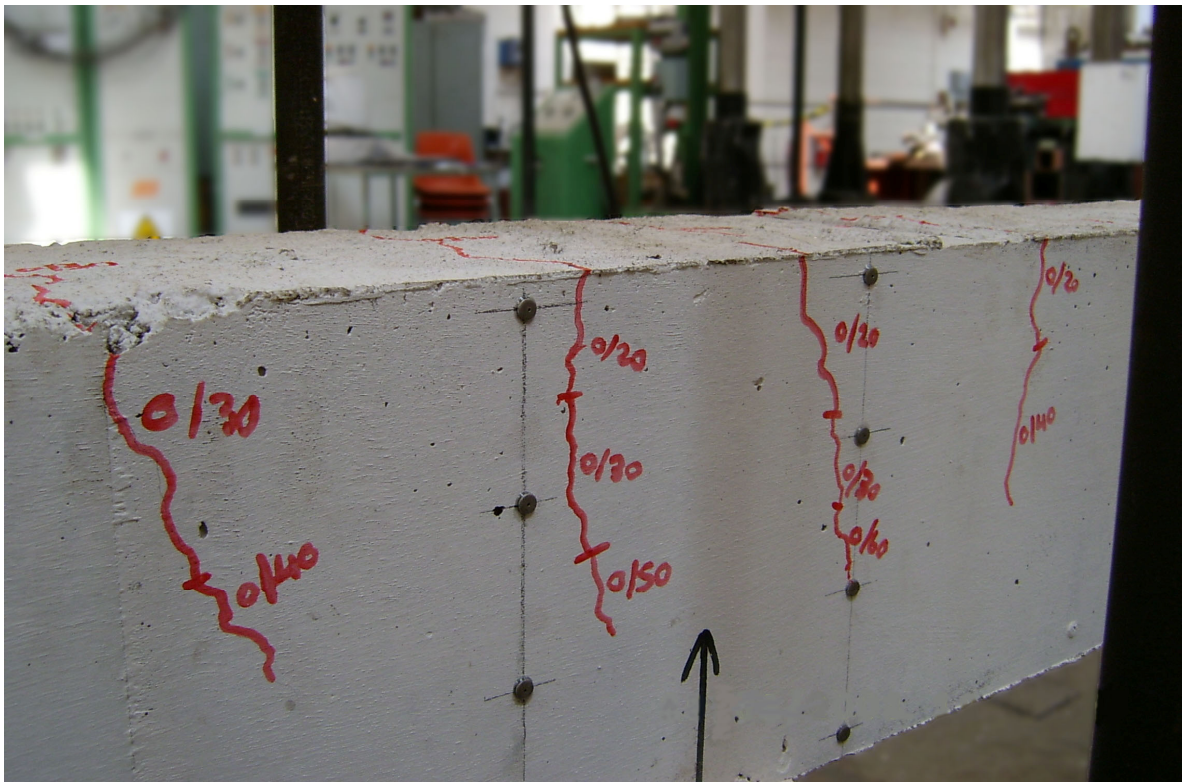
Fig. 6.5: Typical crack pattern above the central support

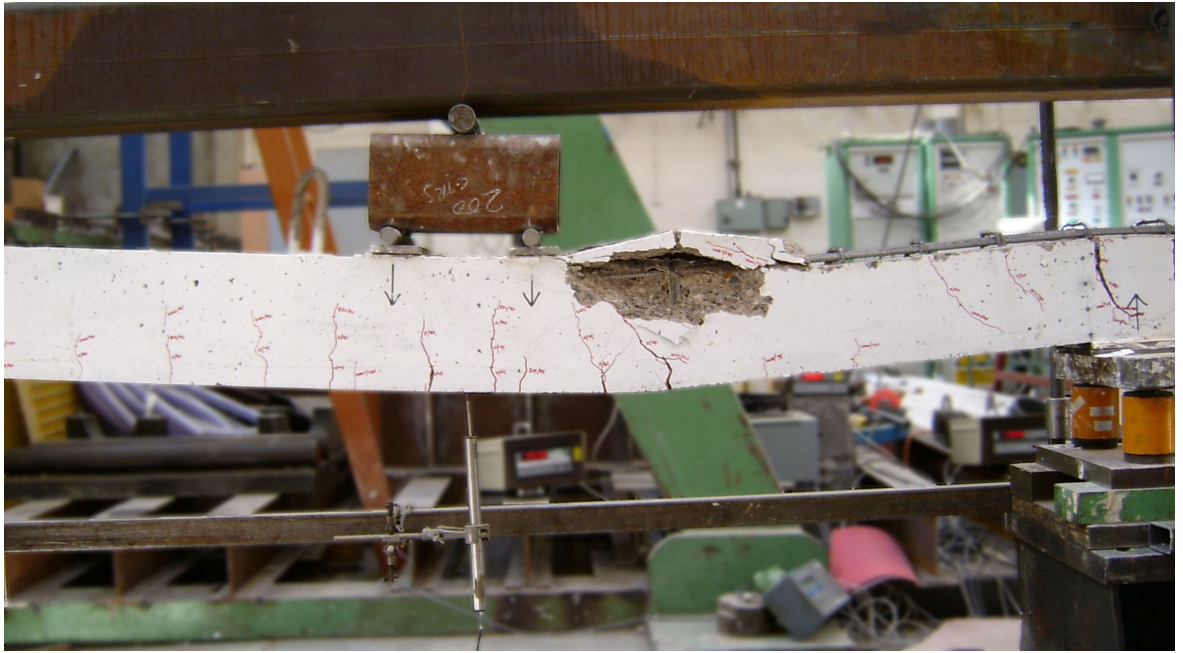
Fig. 7.7: Flexural failure for breakout over the central support (AB21H)

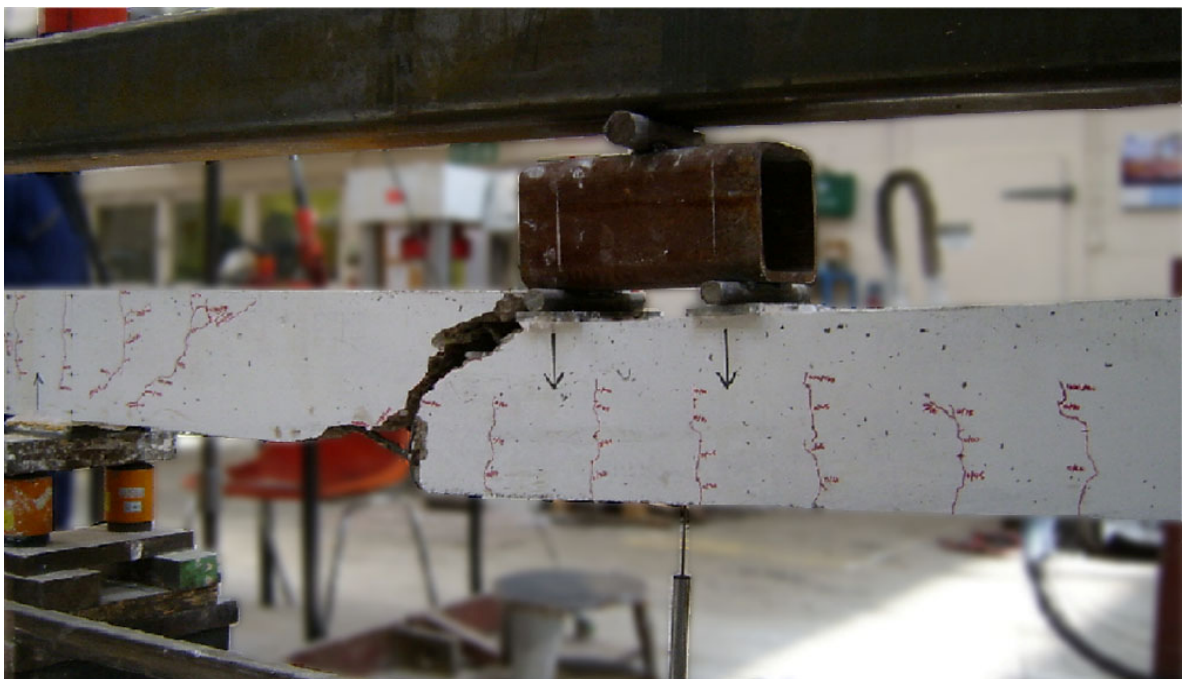
Fig. 7.8: Shear failure within right span for breakout within the left span (AB21S)

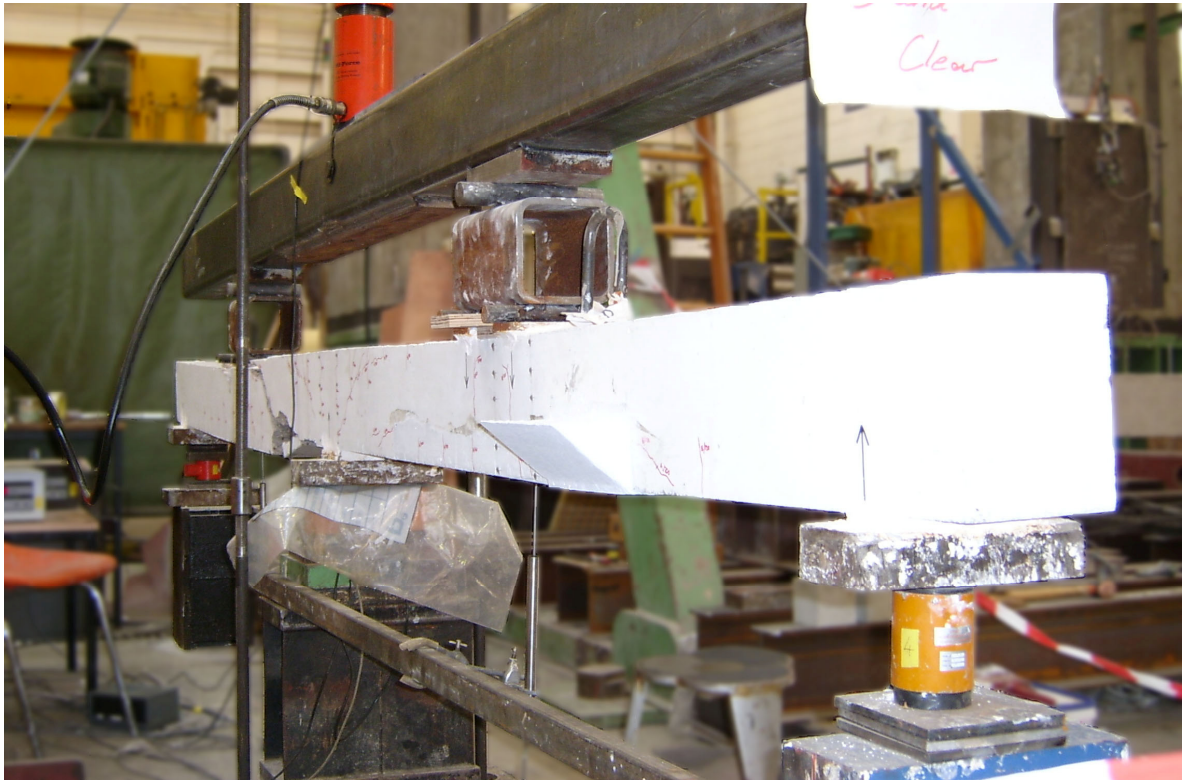
Fig. 7.14: Shear failure of UR23S (within non-repaired span)
